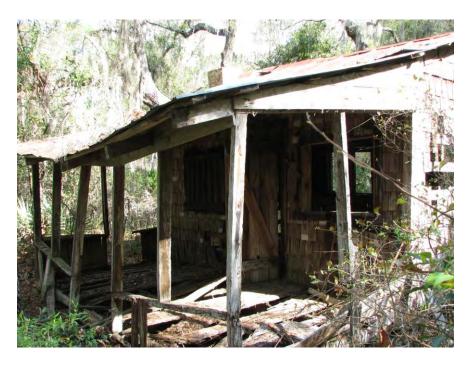
Close-up of deterioration in 2007. (2007-03-15, IMG 0352)

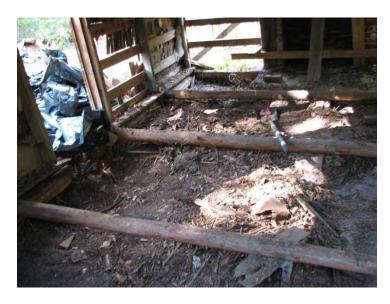
Rodent debris under cabin floor being removed. (2009-11-23, IMG 3985)

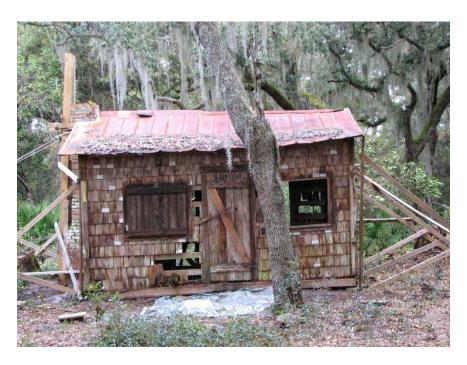
Cabin with straightened chimney. Note top right corner having moved ca. 8-10" from the released bracing to achieve level. Jeff intentionally incorporated the chimney wall in with his interior "strongbacks" for additional support, which allowed the structure to "right" itself, while still attached to the chimney. (2009-13-03, IMG4013)

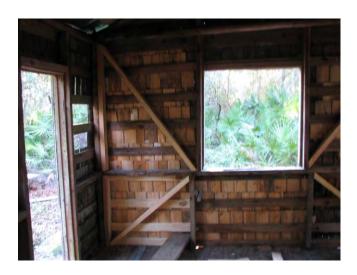
Jeff was able to save all the original, peeled pine rafters and uprights in the cabin. However, to do so, and still provide structural stability, he added rough cut pine interior diagonal bracing, as per Shepard's stabilization protocol. Also, due to decay of some of the bases of the peeled pine pole uprights, he "sistered" vertical rough cut timber to the weakened pole, as per protocol and discussion with Herschel Shepard.

(2011_02_22, IMG 4829) Interior bracing

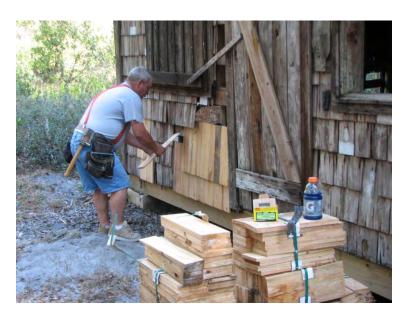
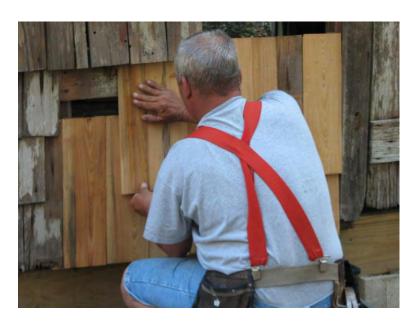
(2011_02_22, IMG 4841)

Next came the painstaking inspection of every existing, original milled cypress siding shingle. Again, all that were structurally sound were left in place. Jeff had a mill in Williston, Florida custom mill matching cypress shingles to replace the rotten shingles and to fill the voids where they were completely missing. All work was by hand. Shingles were cut and shaped when necessary with a vintage roofer's hatchet and then hand nailed in place.

(2011_02_22, IMG 4845) Above and below: Inspecting, selecting, shaping and placing cypress shingle siding.
